## PROYECTO PILOTO SOBRE UN SISTEMA DE SEGUIMIENTO ELECTRÓNICO REMOTO (REM) A BORDO DE LOS BUQUES DE TRANSFORMACIÓN DE ATÚN ROJO

## PILOT PROJECT ON A REMOTE ELECTRONIC MONITORING (REM) SYSTEM FOR BLUEFIN TUNA PROCESSING VESSELS

**FINAL REPORT**

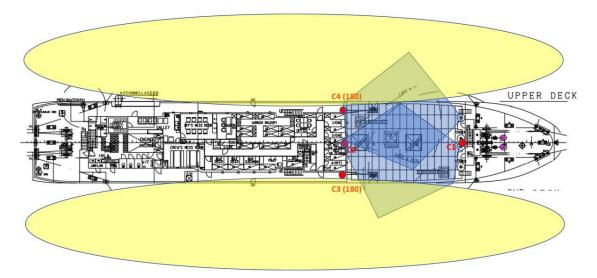
Due to this project objectives the following 4-camera placement was proposed, so all wells and board-side interactions would be monitored:

After data quality was deemed useful with the camera arrangement from phase 1, we used the same disposition for the second phase. For this second installation, we again assisted our partners in installing the SeaTube systems at the ports they were finishing maintenance and, also, shipped the sensor array so the whole solution was installed and the VMPs were updated.

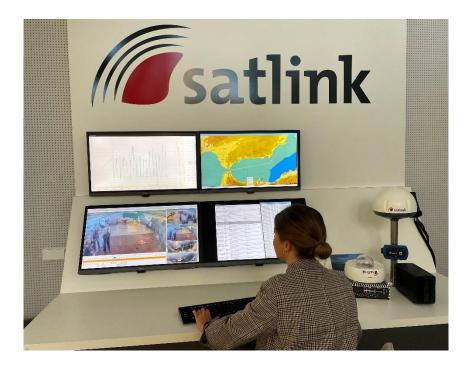
For analyzing the hard drives, DOS used Satlink View Manager (SVM) which is the software solution for in-detail scientific analysis of REM data. This software allows to check different data inputs at once through its multiple window display:

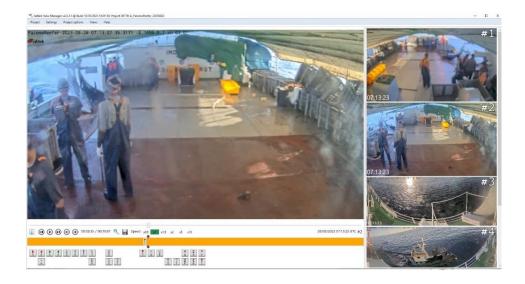
#### Main video Window

Displays the whole camera array synchronously, while focusing on one of the cameras, which will be the one being analyzed and displayed in the bigger screen:

The buttons below the main video are the custom notes the analyst can use to add information to the analysis. These buttons are fully customizable if the project being analyzed would need any particular information added.

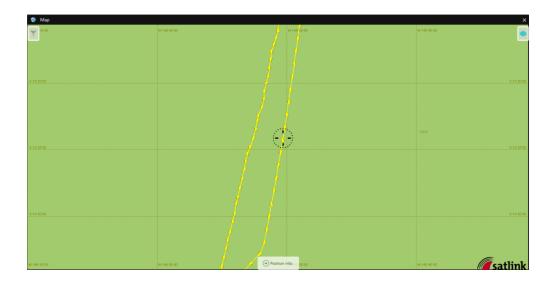
#### Map Window

The map shows the whole track of the trip being analyzed by DOS.

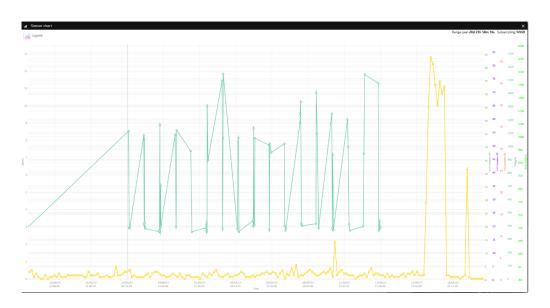
#### Sensor data chart Window

In this window the analyst will always find the speed graph of the trip, since it is calculated with GPS data, besides that info (in yellow), if the SeaTube had any kind of sensor input it will appear in the chart.

In this example, we have the speed in yellow and the weight recorded by the crane scale in green. Fluctuations in the weight value could easily come from the balancing of the fish when hauled.

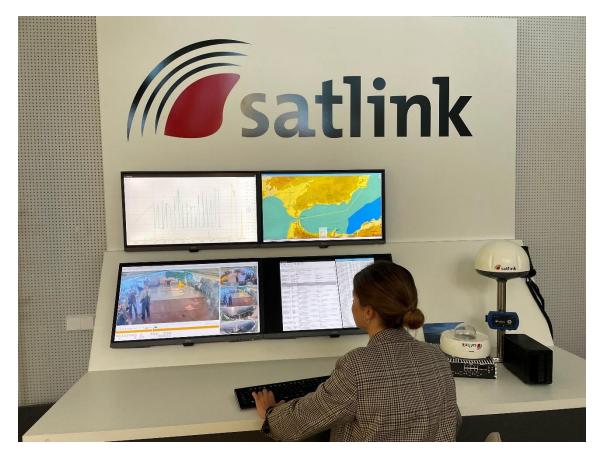
Once the drives arrive to DOS' office, they are decrypted and analyzed using Satlink View Manager (SVM), which is Satlink's proprietary software for Electronic Monitoring data analysis:
