PWG\_411\_REV/2024

**PROJET PILOTE SUR UN SYSTÈME DE  
SURVEILLANCE ÉLECTRONIQUE A DISTANCE (REM)  
À BORD DES NAVIRES DE TRANSFORMATION DU  
THON ROUGE  
RÉSUMÉ EXÉCUTIF**

**PILOT PROJECT ON A REMOTE  
ELECTRONIC MONITORING (REM) SYSTEM  
FOR BLUEFIN TUNA PROCESSING VESSELS  
FINAL REPORT**

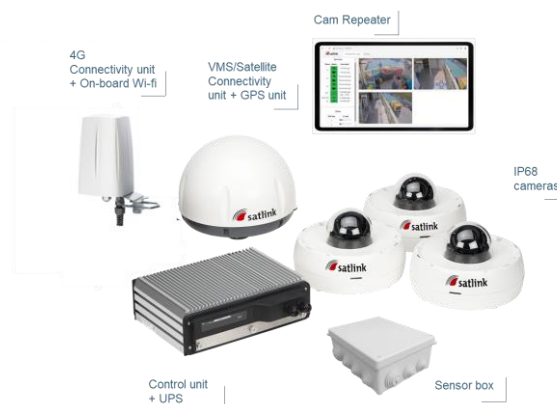
Figure 1 - Standard SeaTube configuration<sup>1</sup>

The SeaTube can be setup in many different configurations in each of the sections it is made of. This flexibility allows to have a tailor-made solution for each customer.

- On-board data recording
  - 24/7
  - Geofencing
  - Sensor based
  - Speed based
  - Other personalized recording methods
- Data transmission from vessel to shore
  - Manual hard drive extraction
  - Satcom/VMS unit
  - GSM/4G
  - Satellite
  - Other personalized transmission methods
- On-shore solution
  - Satlink View Manager desktop-based review software
  - Horus web-based review software

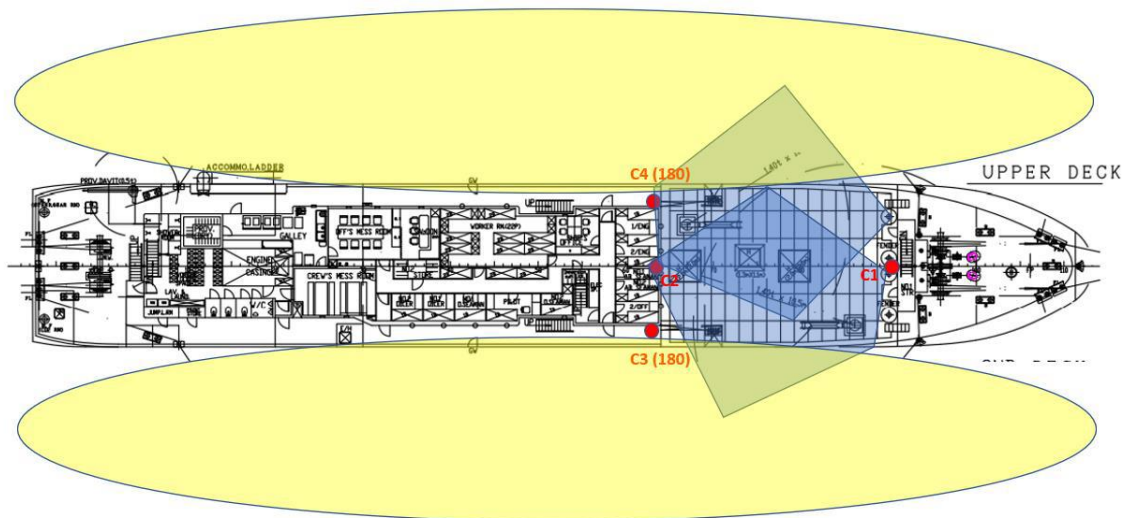
Due to this project objectives the following 4-camera placement was proposed, so all wells and board-side interactions would be monitored:

After data quality was deemed useful with the camera arrangement from phase 1, we used the same disposition for the second phase. For this second installation, we again assisted our partners in installing the SeaTube systems at the ports they were finishing maintenance and, also, shipped the sensor array so the whole solution was installed and the VMPs were updated.

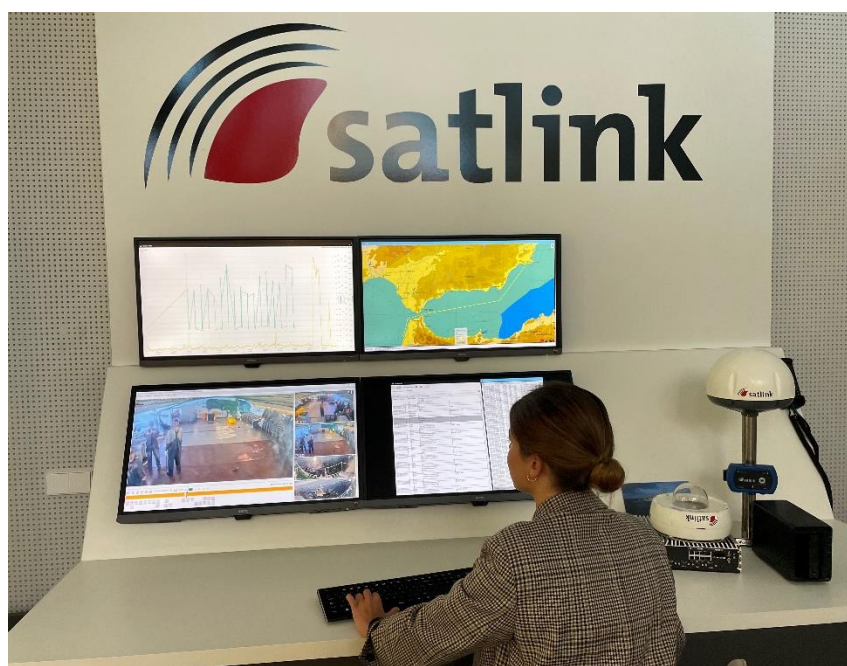
For analyzing the hard drives, DOS used Satlink View Manager (SVM) which is the software solution for in-detail scientific analysis of REM data. This software allows to check different data inputs at once through its multiple window display:

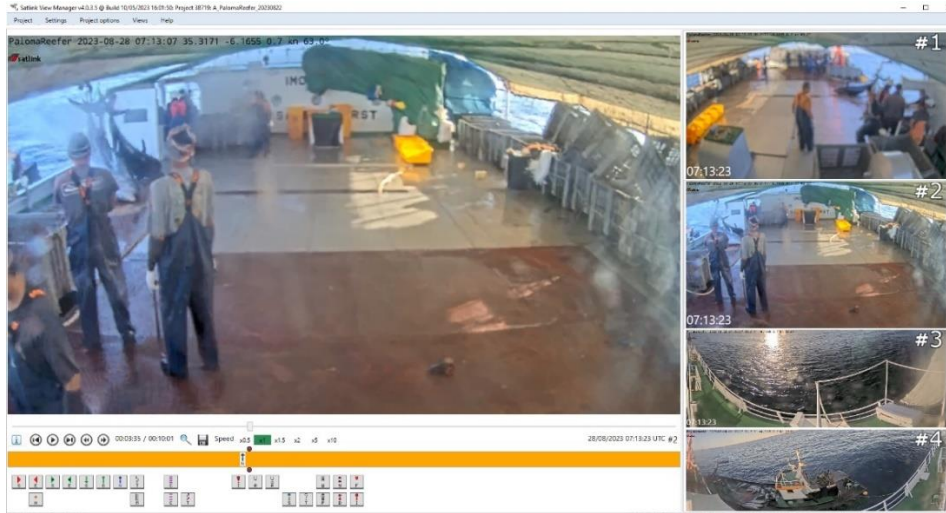
### Main video Window

Displays the whole camera array synchronously, while focusing on one of the cameras, which will be the one being analyzed and displayed in the bigger screen:

The buttons below the main video are the custom notes the analyst can use to add information to the analysis. These buttons are fully customizable if the project being analyzed would need any particular information added.

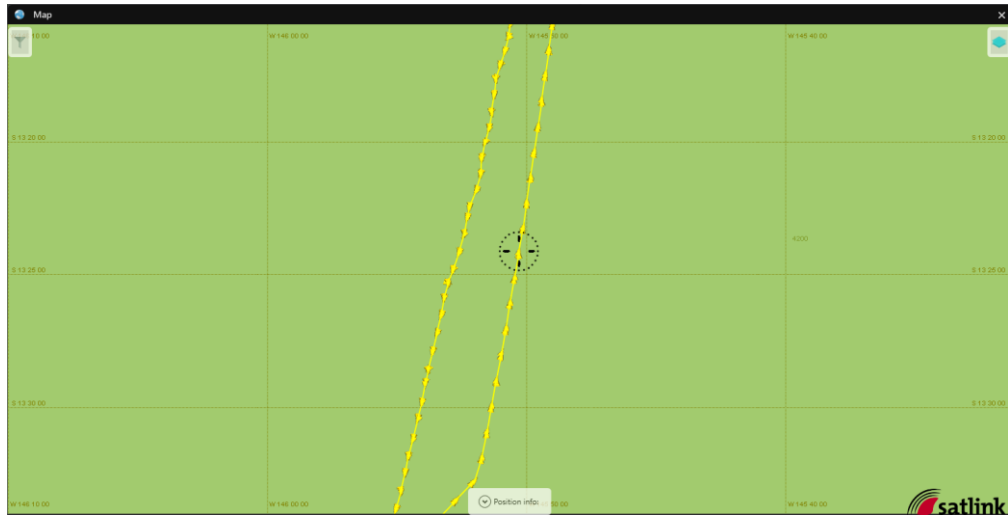
### Map Window

The map shows the whole track of the trip being analyzed by DOS.

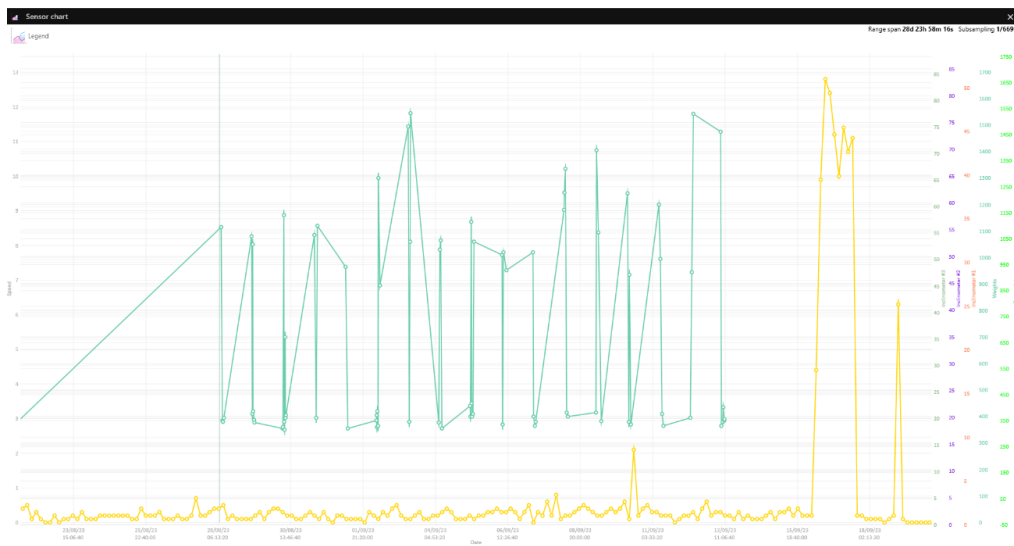
### Sensor data chart Window

In this window the analyst will always find the speed graph of the trip, since it is calculated with GPS data, besides that info (in yellow), if the SeaTube had any kind of sensor input it will appear in the chart.

In this example, we have the speed in yellow and the weight recorded by the crane scale in green. Fluctuations in the weight value could easily come from the balancing of the fish when hauled.

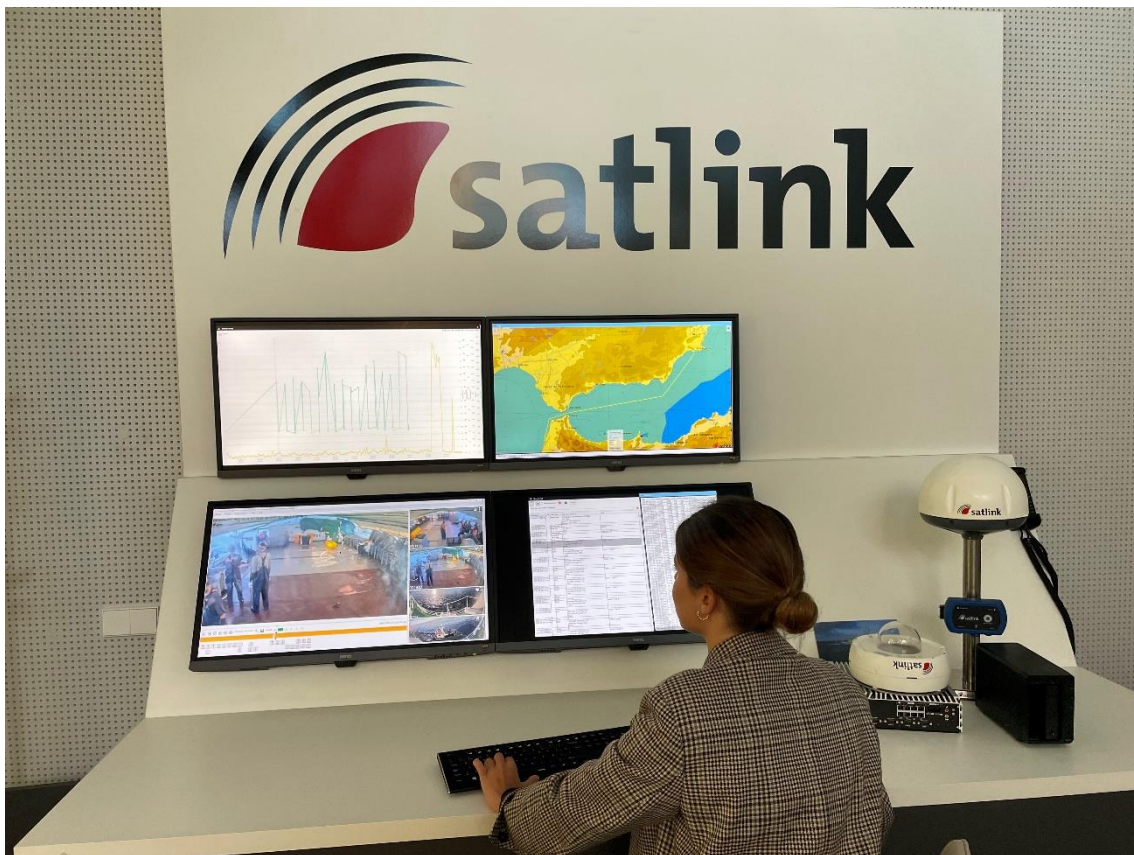
Once the drives arrive to DOS' office, they are decrypted and analyzed using Satlink View Manager (SVM), which is Satlink's proprietary software for Electronic Monitoring data analysis:

In the analysis of the video of a cargo vessel trip, we separate the effort dedicated to detect the transfer operations made during the vessel's trip (Screening\_TR process) and the description of the transferred fish (Standard\_TR).
